INDOOR AIR QUALITY ASSESSMENT

**Weston Fire Department
Station 2
390 South Ave, Route 30
Weston, Massachusetts**

Prepared by:
Massachusetts Department of Public Health
Center for Environmental Health
Emergency Response/Indoor Air Quality Program
September 2005

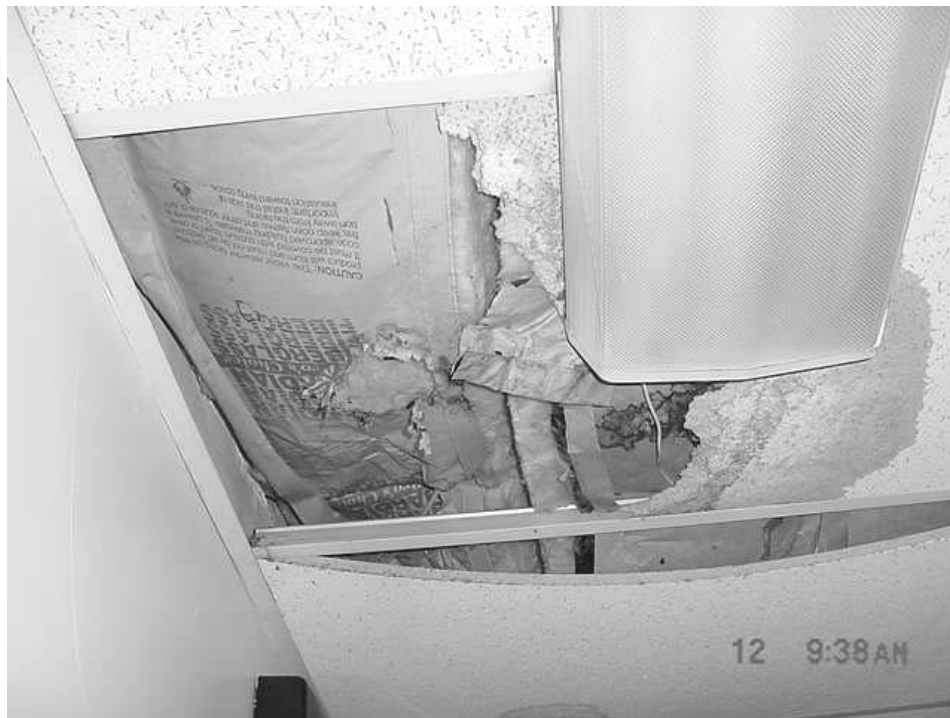
Picture 1

The station has reportedly experienced problems with water penetration through the roof and building envelope. Water-damaged ceiling tiles and fiberglass insulation were observed throughout the station (Pictures 1 to 3). Water-damaged porous building materials can provide a source of mold and should be replaced after a leak is discovered and repaired. Visible mold growth was observed on the paper backing of fiberglass

Water Damaged/Mold Colonized Ceiling Tiles and Fiberglass Insulation

5. Ensure that moss growth/water-stained exterior brick are cleaned and disinfected.
6. Continue with plans to replace roof and ceiling tile systems. Particular attention should be made to examine areas of water leaks for microbial growth. Disinfect these areas with an appropriate antimicrobial as necessary.

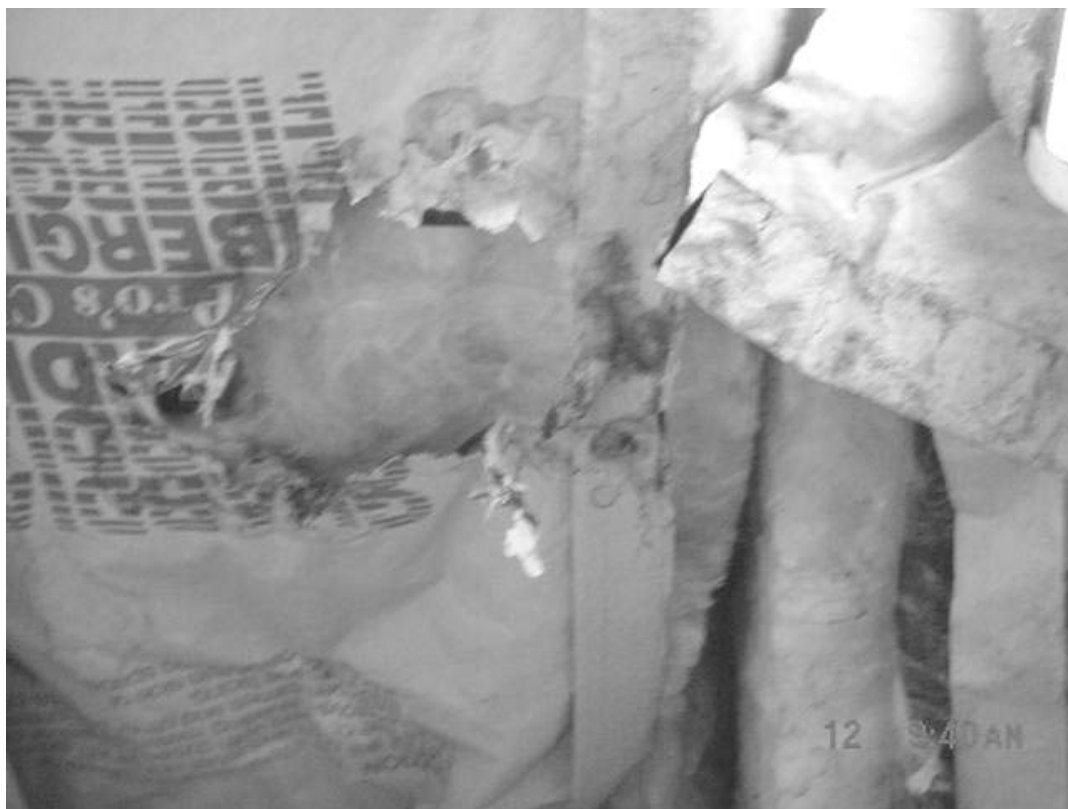
Picture 2

Close-Up of Water Damaged/Mold Colonized Fiberglass Insulation

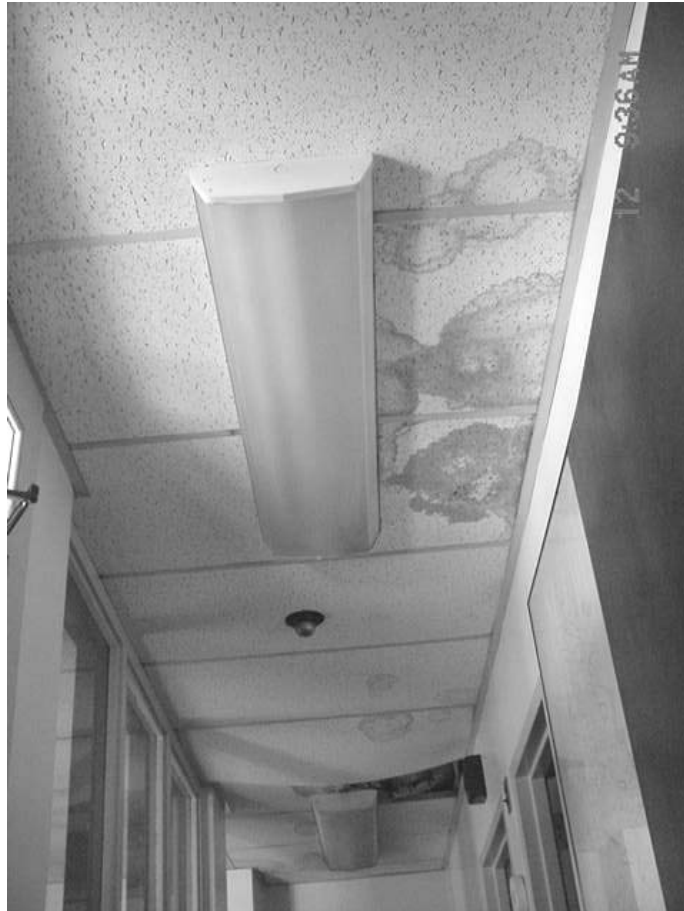
Picture 3

insulation in the main hallway (Picture 3). Visible mold growth was also observed on pipe wrapping in the basement (Picture 4). The US Environmental Protection Agency and the American Conference of Governmental Industrial Hygienists (ACGIH) recommends that porous materials (e.g. wallboard, ceiling tiles, carpeting) be dried with fans and heating within 24 to 48 hours of becoming wet (US EPA, 2001; ACGIH, 1989). If not dried within this time frame, mold growth may occur. Once mold has colonized porous materials, they are difficult to clean and should be removed.

Water Damaged/Mold Colonized Ceiling Tiles and Fiberglass Insulation

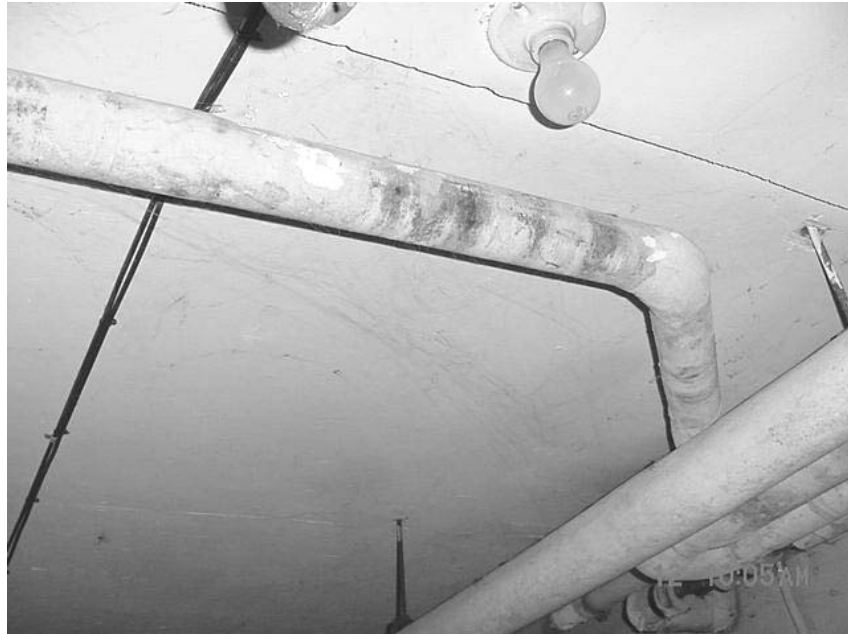
Picture 4

Mold Colonized Pipe Insulation in Basement

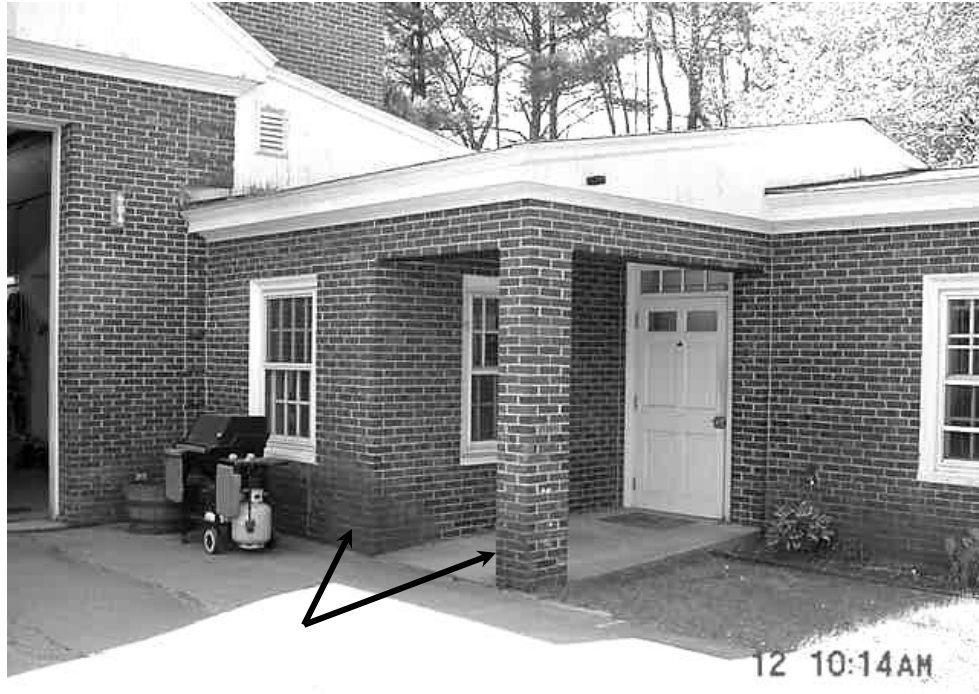
Picture 5

- Discoloration and moss growth was seen on brick along the front wall of the building, indicating an area of chronic water accumulation/backsplashing. The water appears to roll off the peaked roof over the front entrance, which is not equipped with a gutter system (Pictures 5 and 6).
- The basement entrance at the rear of the building is equipped with a drain, which was clogged with leaves and debris (Picture 7). Water accumulation and penetration was evident in this area due to severe corrosion of a wooden door located at the rear of the building, as a result the door was sealed with plastic sheeting (Picture 8).
- Spaces, missing/damaged mortar around masonry was observed at the rear of the building (Pictures 9 and 10), and
- Open utility holes (Pictures 11 and 12) and spaces around window frames were seen around the exterior of the building (Pictures 13 and 14).

Entrance to Station 2, Note Lack of Gutter/Downspout System Resulting in Moss Growth/Discoloration of Brick

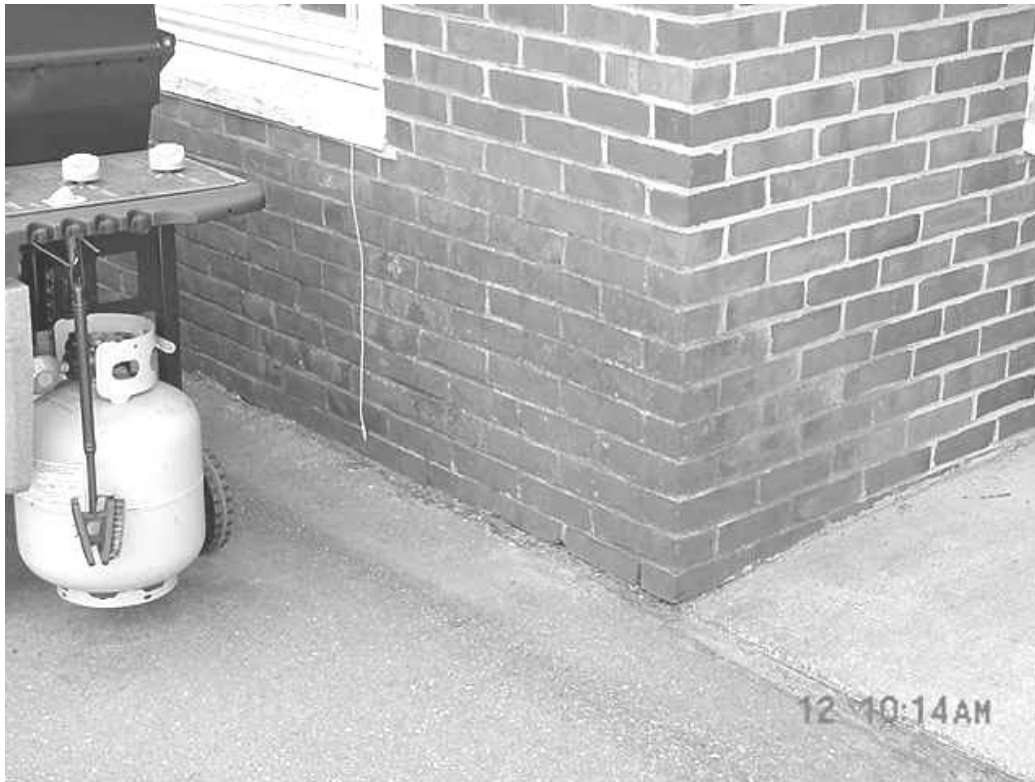
Picture 6

Close-Up of Moss Growth/Discoloration of Brick in Preceding Picture

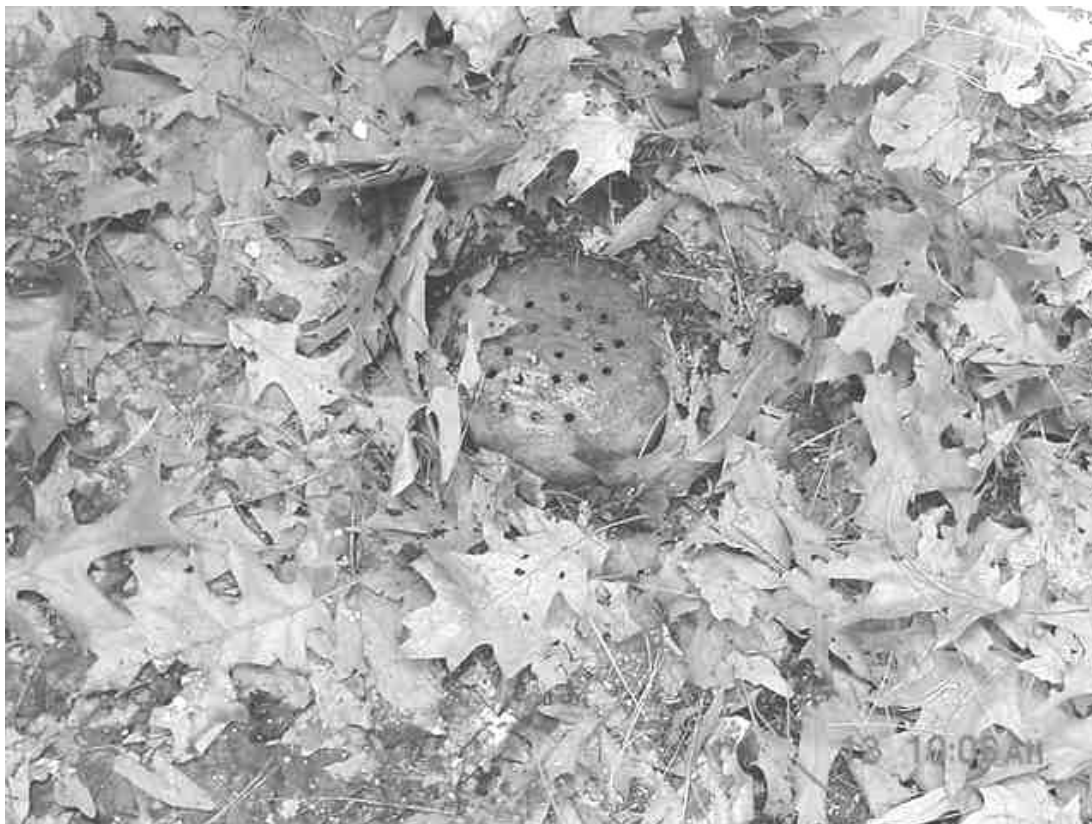
Picture 7

Clogged Drain

9. Unclog exterior drain and inspect regularly for proper drainage.
10. Replace damaged exterior door for rear entrance.
11. Reactivate bathroom exhaust vents, repair/replace motors as needed.

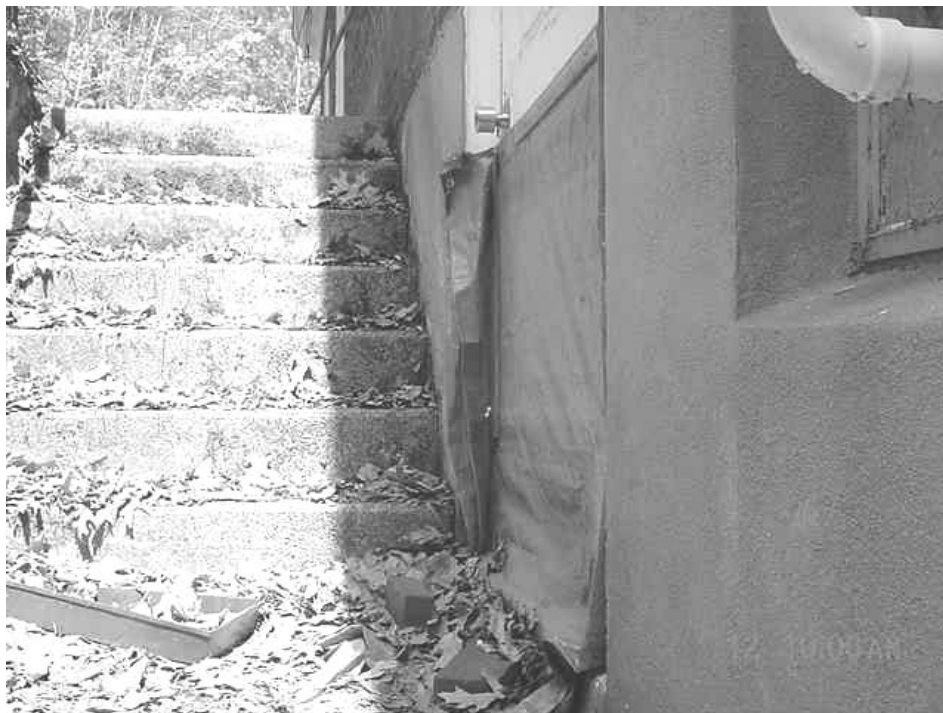
Picture 8

Severely Corroded Door Sealed with Plastic Sheetting

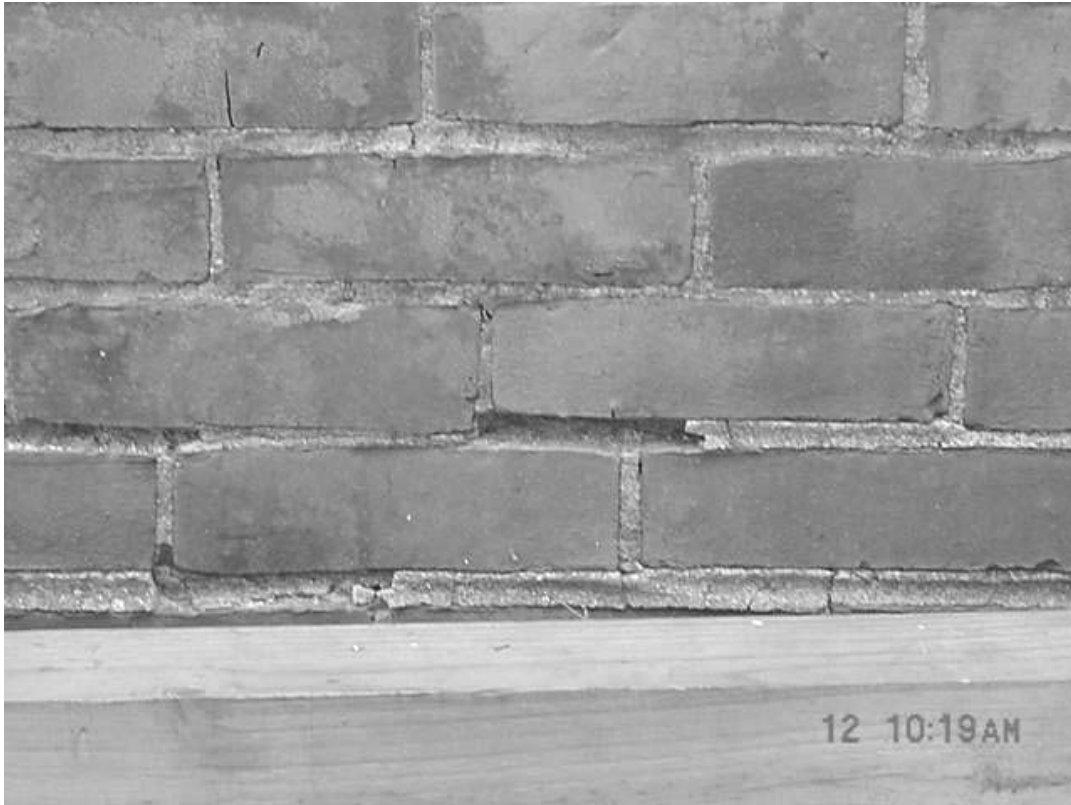
Picture 9

Moss Growth and Missing/Damaged Mortar on Rear of Building

7. Repair breaches in the building envelope including, cracks in walls, missing/damaged flashing and open utility holes.
8. Make repairs to windows to eliminate spaces around frames.

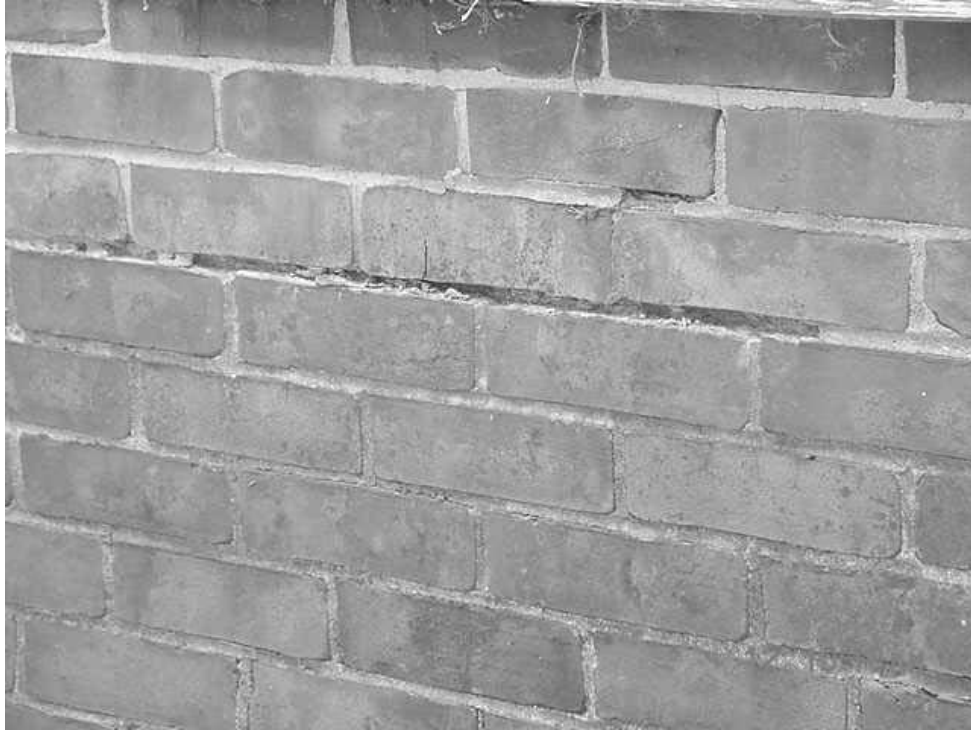
Picture 10

Moss Growth and Missing/Damaged Mortar on Rear of Building

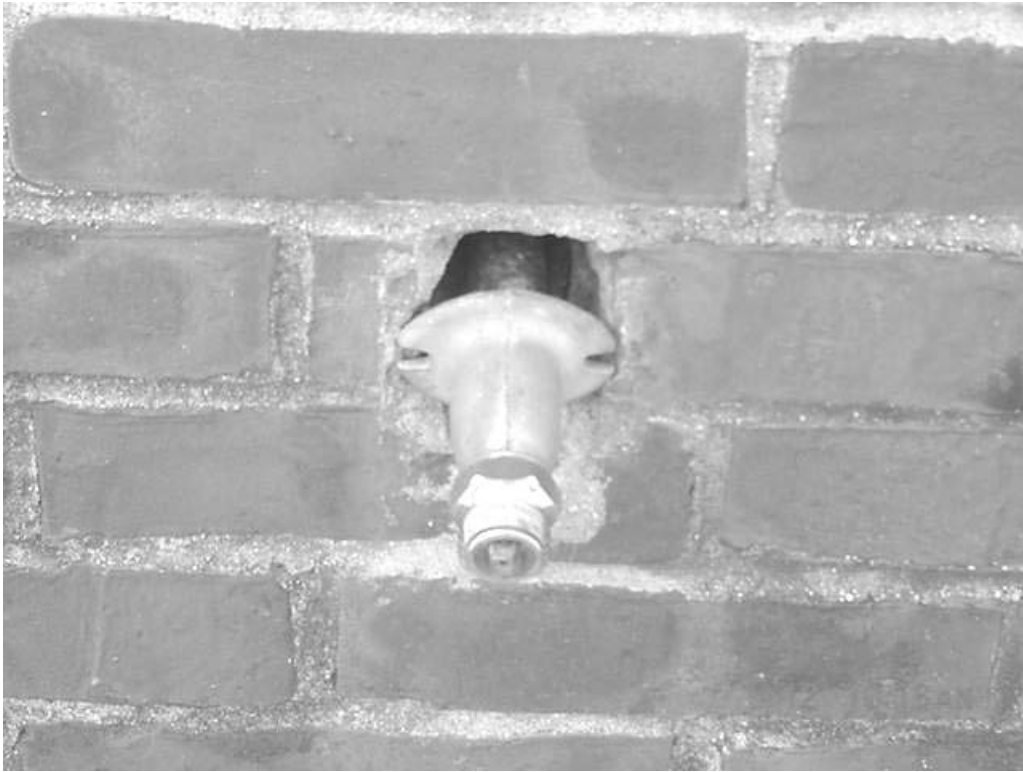
Picture 11

Open Utility Hole around Water Spigot

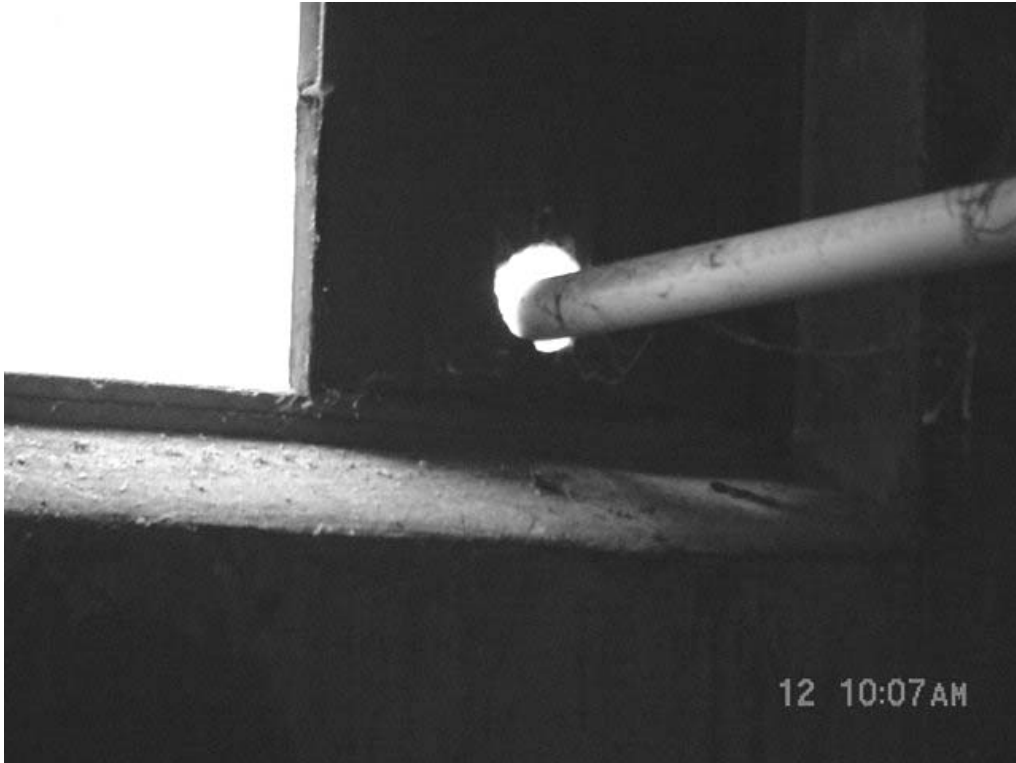
Picture 12

Utility Hole around Pipe

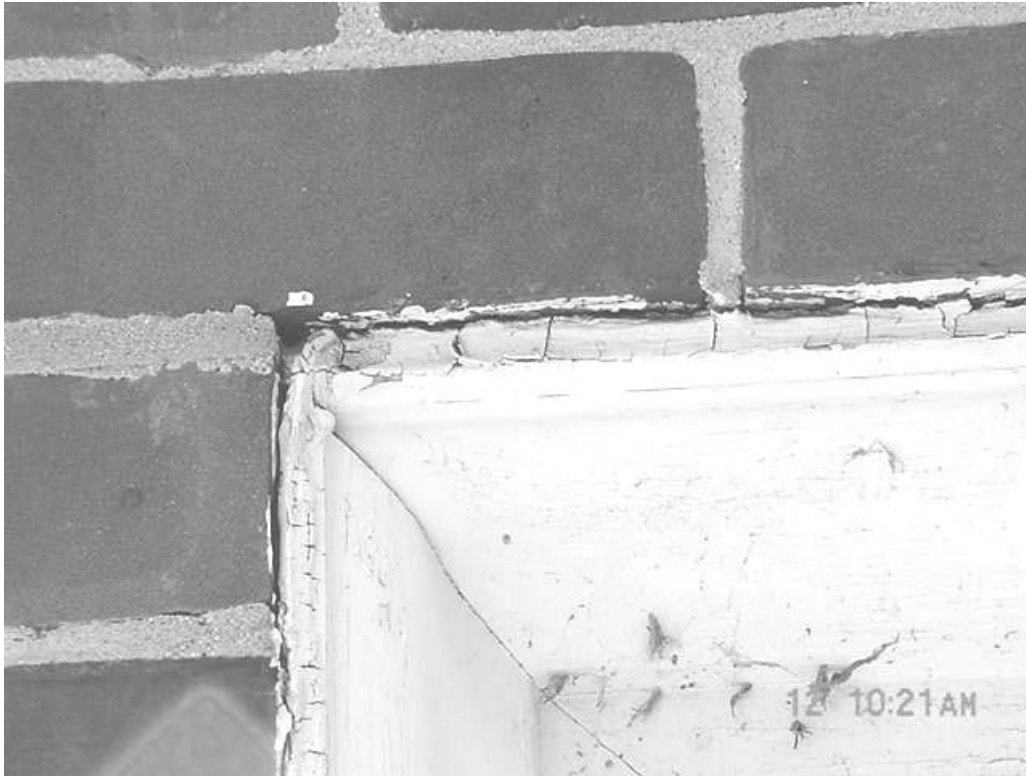
Picture 13

Spaces between Brick and Window Frames

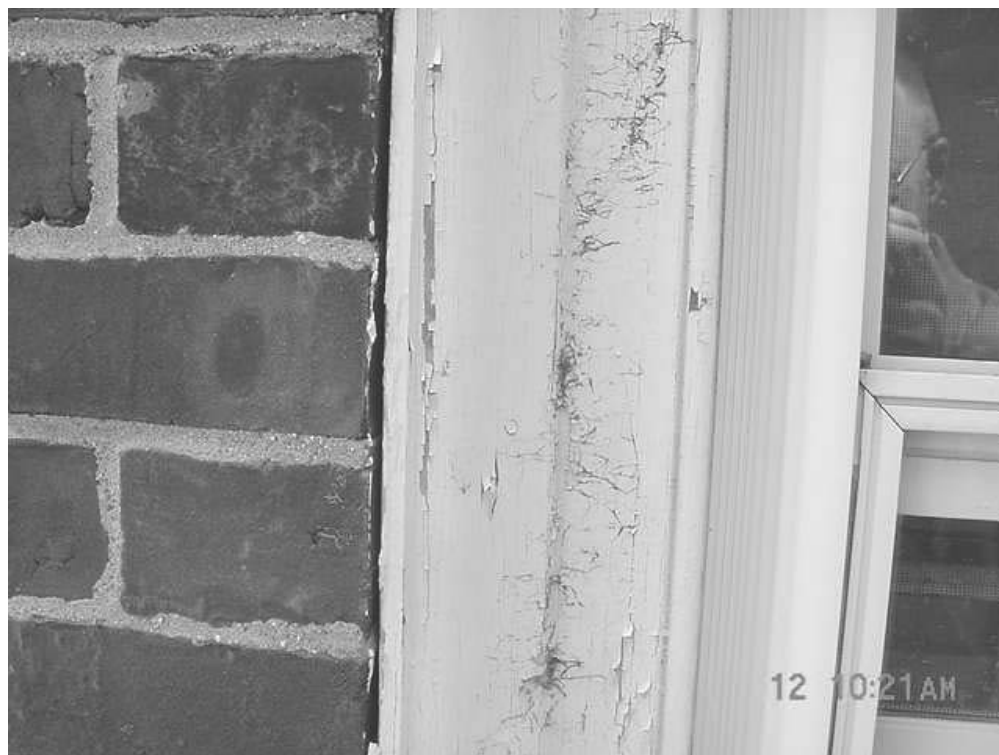
Picture 14

Spaces between Brick and Window Frames

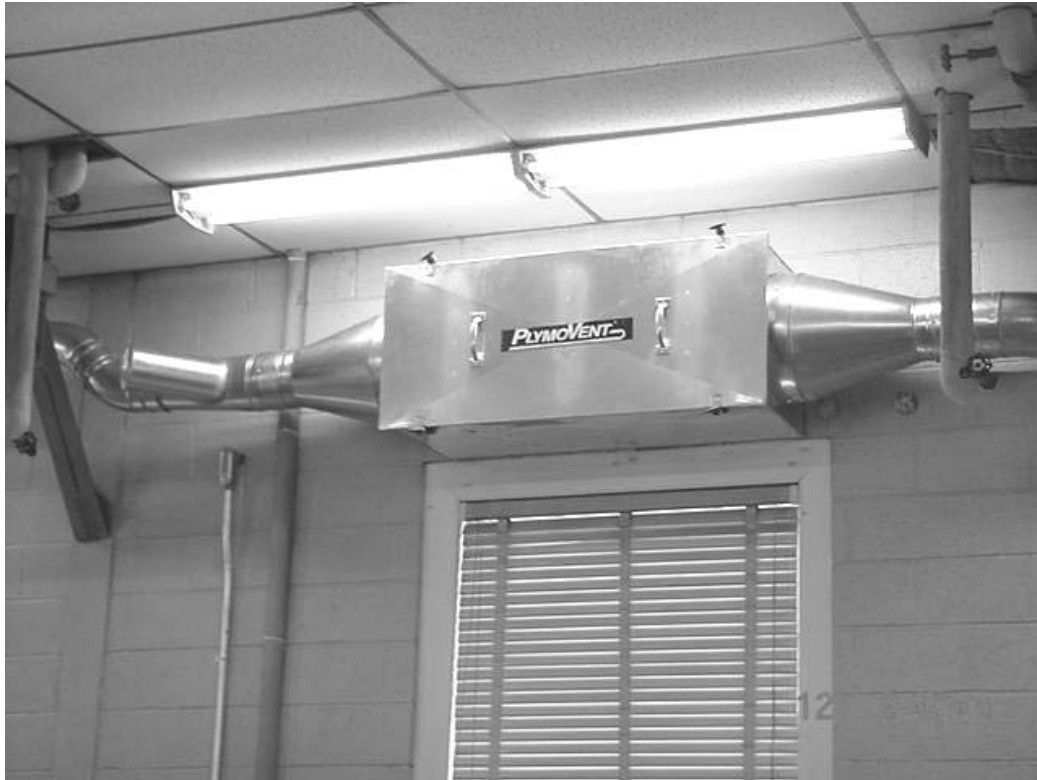
Picture 15

As mentioned previously, the station is equipped with a mechanical exhaust system to remove exhaust from the engine bay during vehicle idling (Picture 15). The system in use at the station connects directly to the tail pipe of the engine via a pressurized cuff (Picture 16). As the vehicle exits the station, the cuff, which is pulled on a runner, trips a trigger releasing the cuff. The system is designed to collect vehicle exhaust directly at the source and remove it from the building, minimizing exposure. Although the engine bay is equipped with local exhaust ventilation, a number of pathways for vehicle exhaust and other pollutants to move from the engine bay into occupied areas were identified (Figure 1). The doors (off the engine bay) leading to the compressor room and watch station had spaces beneath the door and light could be seen penetrating into the stairwell through these spaces (Picture 17).

Local Exhaust Ventilation System in Engine Bay

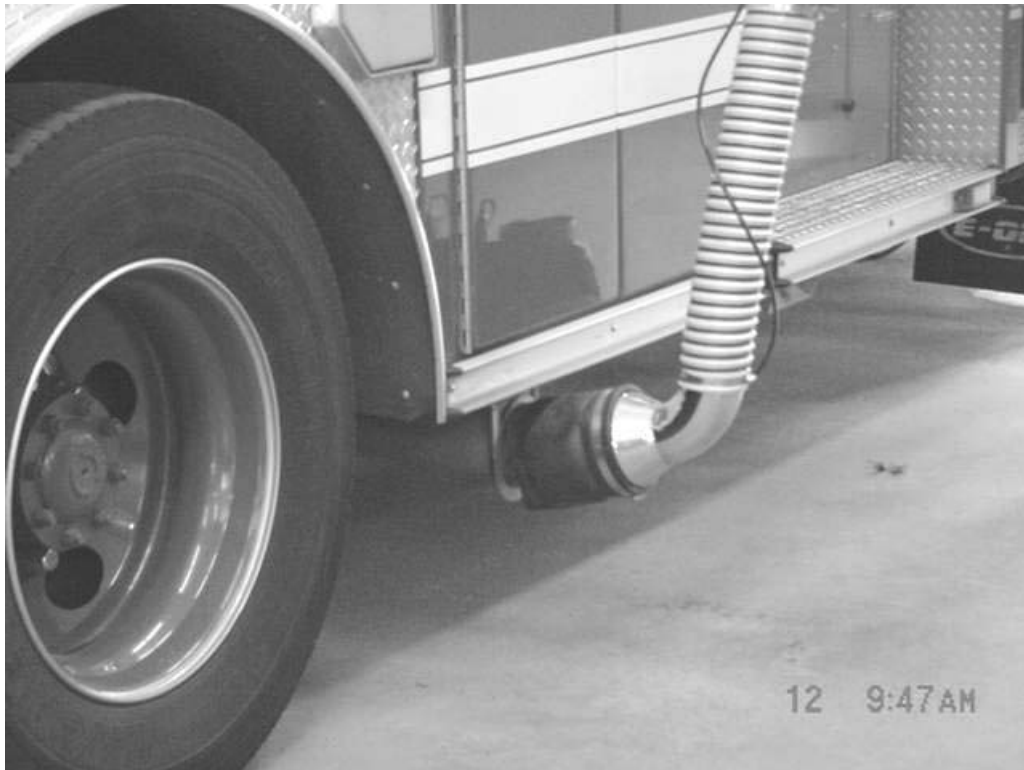
Picture 16

Pressurized Cuff on Tailpipe for Local Ventilation System

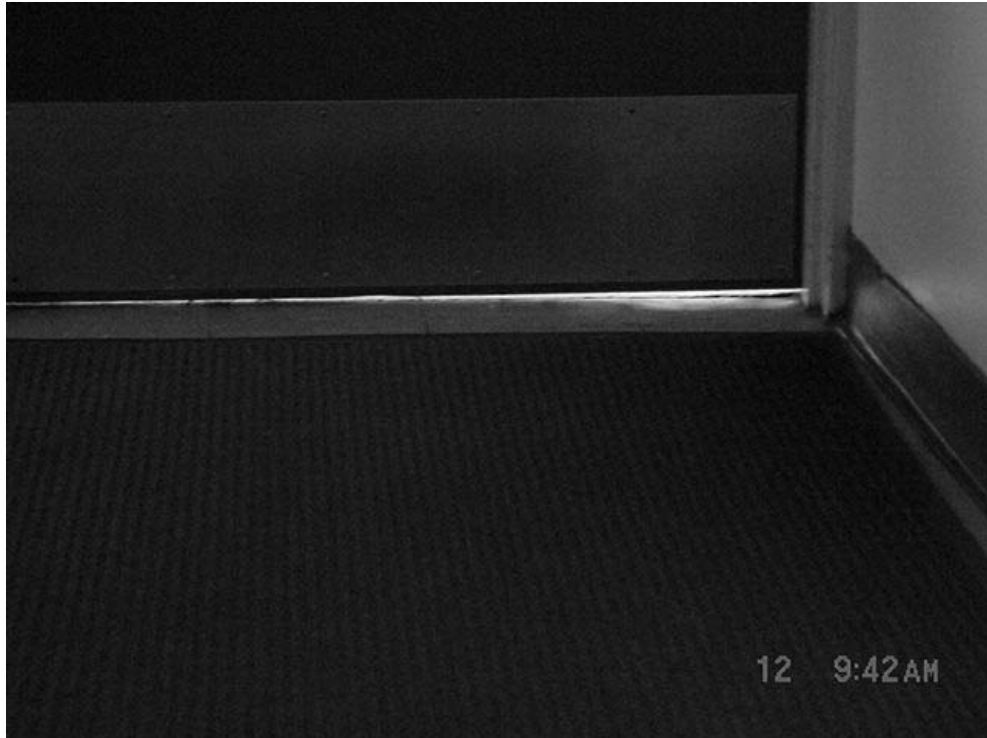
Picture 17

Spaces under Door off Engine Bay

1. Ensure exposed/damaged pipe insulation material in the basement is encapsulated/remediated in conformance with all applicable Massachusetts laws.
2. Ensure doors with access to the engine bay fit completely flush with threshold. Seal doors on all sides with foam tape and/or weather-stripping. Consider installing weather-stripping/door sweeps on both sides of doors with access to the engine bay to provide a dual barrier. Ensure tightness of doors by monitoring for light penetration and drafts around doorframes.
3. Ensure utility holes are properly sealed in both the engine bay and their terminus to eliminate pollutant paths of migration.

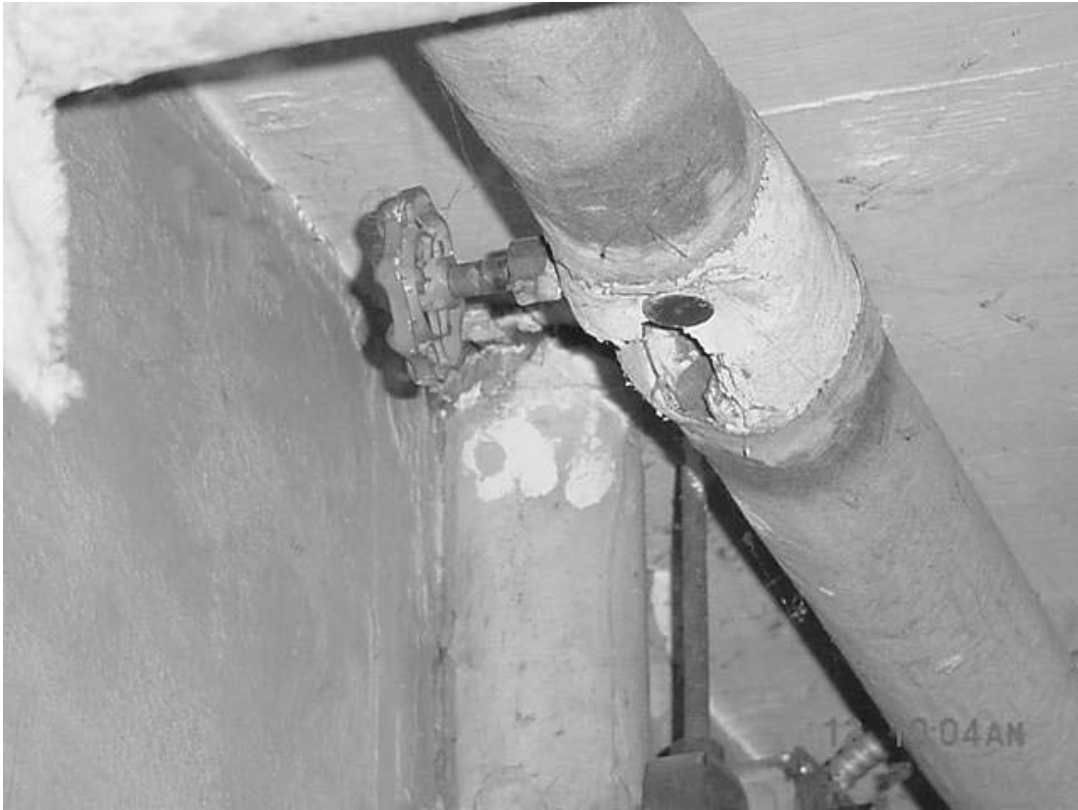
Picture 18

Several other conditions that can potentially affect indoor air quality were identified. Damaged/exposed pipe insulation was observed in the basement (Pictures 18 and 19). The pipe insulation may contain asbestos. At the time of the assessment MDPH

Damaged/Exposed Pipe Insulation in Basement

staff recommended that the material be encapsulated by a licensed member of the Weston town maintenance staff or other professional contractor as soon as practicable.

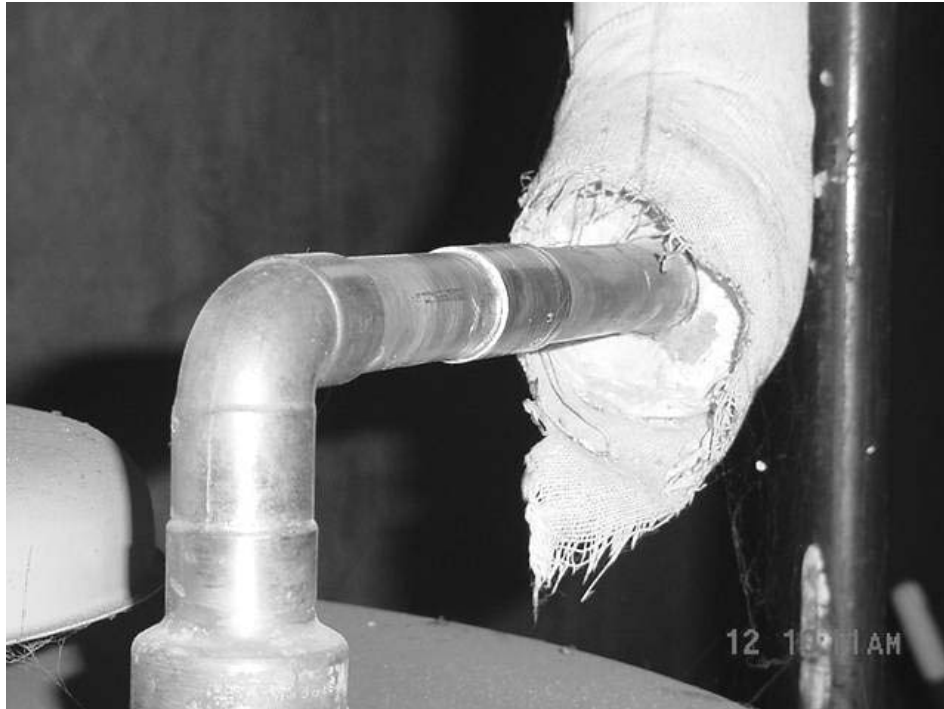
Picture 19

Damaged/Exposed Pipe Insulation in Basement

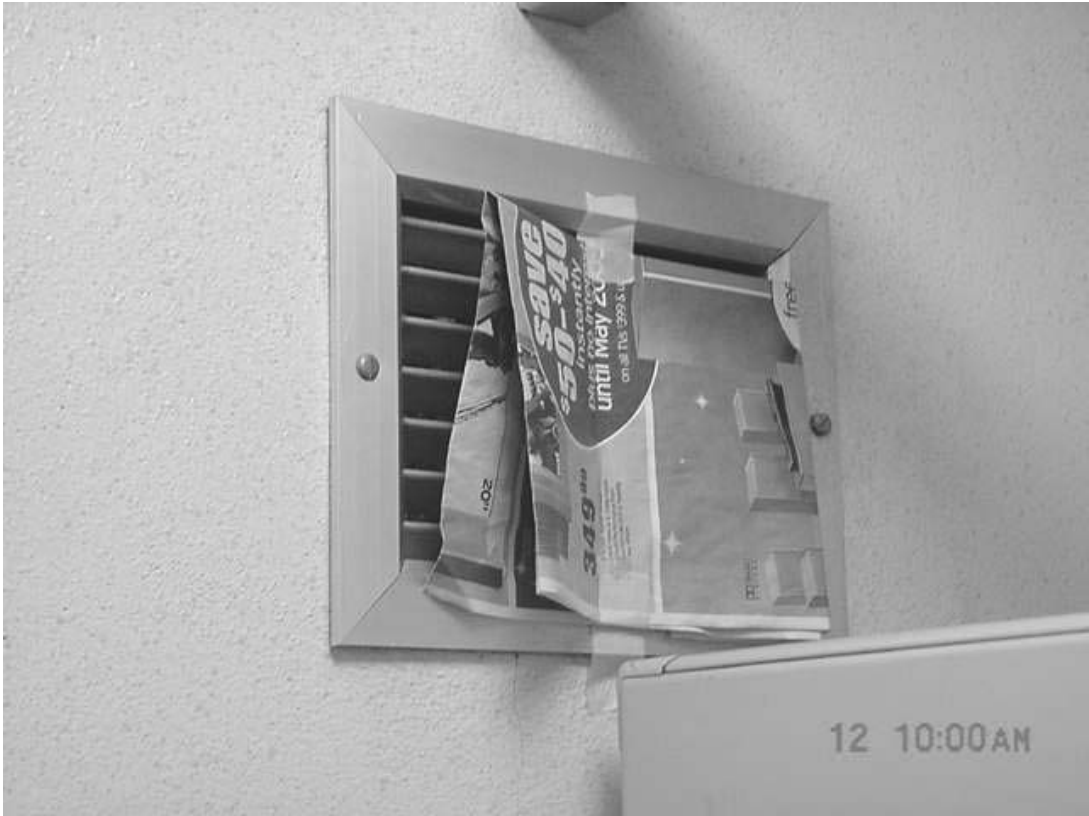
Picture 20

Finally, local exhaust ventilation in restrooms was not functioning during the assessment. Several of the vents were blocked with cardboard presumably to prevent drafts from backdrafting (Picture 20). Exhaust ventilation is necessary in restrooms to remove moisture and to prevent restroom odors from penetrating into adjacent areas.

Exhaust Vent in Bathroom Sealed to Prevent Drafts
